A look into the emerging seam

ThermoProfilScanner (TPS)

Principle of operation ThermoProfilScanner

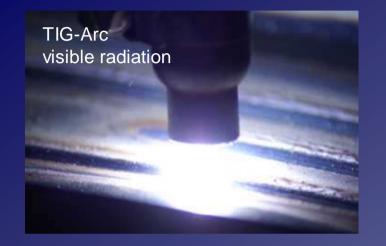
The view through the arc into the heat signature

Local heat input is melting and is changing the structure of materials during brazing and welding processes.

The correct heat input and also the undisturbed heat distribution is an important attribute for the evaluation of welding seams.

The human eye can not see heat radiation. The glare of the visible part of an arc is so intense, it will cover up any heat information.

TIG - Arc Heat radiation only Herefor technology is required that can capture the heat information in spite of:Massive glare of the arc

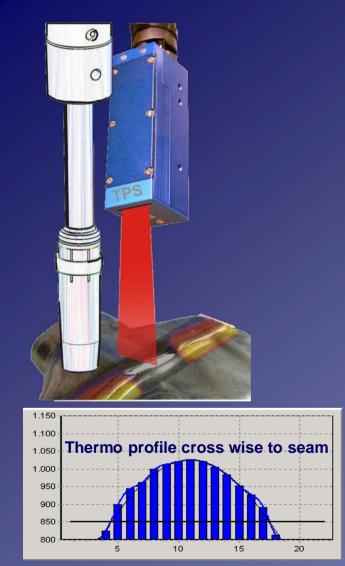
The Thermoprofilscanner is constantly capturing a thermo profile **across the welding seam**.

Hereby it is able to fade out the visible light from the arc. A heat image of the welding seam is created by the continues movement of the welding torch.

- Work distance 15 to 120 mm
- Scan frequency < 400 Profiles/s allowing a resolution of better than 1 mm by speeds up to 20 m/min.
- Advanced design features allow
 Indefinite operation very close to torch:
 - ✓ Glass free design
 - ✓ Gas curtain
 - Anti spatter concept
 - ✓ Integrated water cooling

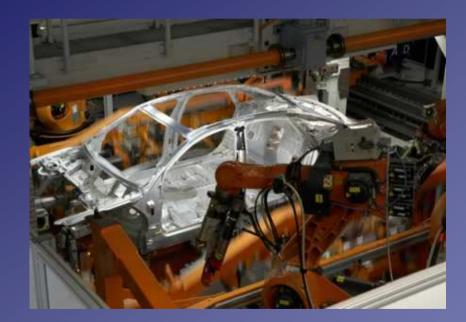
Robot guided brazing of car bodies with Plasmatron

Recognition of visible welding inconsistencies as fusion faults and pores larger than 1 mm.

ThermoProfilScanner offset to the torch: 7 mm scan frequency: 140 Hz resolution: 0,9 mm work distance: 130 mm purging gas: 3 l/min welding speed: up to 3 m/min no water cooling

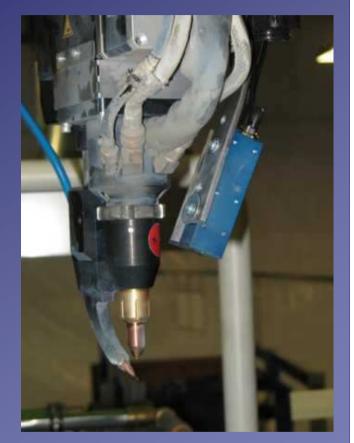
The immediate fault recognition is prevention the part being used for the total body assembly. The resulting cost savings amount to 1000 EUR per detected fault .

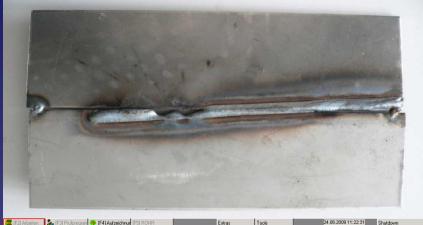
fault image: root layer penetration, lack of side-fusion, holes (burn trough)

The TPS allows for the first time a thermographic evaluation of various welding seams.
